# "OOPS, IT DIDN'T ARM." - A CASE STUDY OF TWO AUTOMATION SURPRISES

Everett Palmer, NASA - Ames Research Center

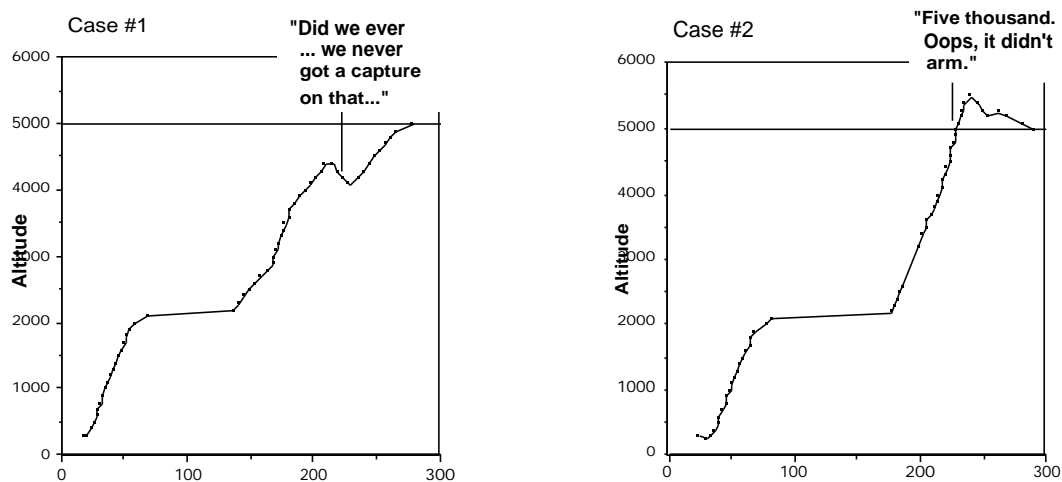
Figure 2. Altitude vs. Time Profiles for Cases 1 & 2.

The crew had just attempted a Category II approach; they did not see the runway at the decision height and made a missed approach. After climbing to 2,100 feet, Air Traffic Control told them, "You're cleared to the 0-0-6 radial at 1-5 miles, climb now and maintain 5,000 feet, let me know when you're ready to copy holding instructions." Their airspeed was 160 knots and the flaps were set to 15 degrees. The altitude window on the Mode Control Panel (MCP) was set to 5000 and the Captain, the pilot flying (PF), pushed first the EPR/LIM button on the MCP and then selected a vertical speed of about 2000 feet per minute. The Flight Mode Annunciator (FMA) now showed the thrust mode to be EPR/GA, altitude capture armed and the pitch mode to be VERT/SPD (Fig. 3.D). The aircraft was climbing at a vertical speed of 2,000 feet a minute and accelerating rapidly because the engines were set to go around thrust. As the aircraft approached 4000 feet, the airspeed was about 240 knots, and the aural voice warning "STABILIZER MOTION" began to repeatedly sound. This warning was caused by the rapid change in airspeed. The Captain mistakenly interpreted the "STABILIZER MOTION" warning as a malfunction - a runaway stabilizer. The Captain changed the pitch mode to IAS (Fig. 3.F) and disconnected the autothrottles and reduced power (Fig. 3.G). The aircraft now had insufficient thrust to maintain 240 knots with flaps at 15 degrees and also climb. The autopilot pitched the aircraft down to maintain 240 knots and the aircraft began to descend before reaching the cleared altitude of 5000 feet. The descent away from the 5000 foot target altitude triggered the "ALTITUDE - ALTITUDE" voice warning. As the aircraft started to descend, the First Officer (FO) said, "You're descending now." After descending to approximately 4000 feet, the Captain pushed the MCP button ALT/HOLD and remarked, "Did we ever ... we never got a capture on that." During the climb the crew had also received holding instructions for an unpublished holding pattern on the 0-0-6 radial and the FO had programmed the new fix and the holding pattern into the Flight Management System. The remainder of the flight was uneventful except that at about 20,000 feet the crew changed the Thrust Reference Panel from GO-AROUND to CLIMB thrust. Figure 2 shows the altitude profiles for the two cases.

The second incident took less than 20 seconds to play out. The crew had just made a missed approach and had climbed to and leveled at 2,100 feet. They received the clearance to "... climb now and maintain 5,000 feet ...". After some communication confusion on the cleared altitude (5,000 or 15,000) and which radial to hold on (0-0-6 or 0-6-0), the Captain set the MCP altitude window to 5,000 feet, set the autopilot pitch mode to vertical speed with a value of approximately 2,000 ft per minute and the autothrottle to SPD mode with a value of 256 knots (Fig. 4.D). Climbing through 3,500 feet the Captain called for flaps up and at 4,000 feet he called for slats retract. As the aircraft climbed from 4,000 to 5,000 feet, the first officer was copying the holding clearance. Climbing through 4,000 feet, the FMA showed: [SPD/255 || ALT || VOR/TRK || VERT/SPD] (Fig. 4.E). Passing through 4,000 feet, the Captain pushed the IAS button on the MCP. The pitch mode became IAS and the autothrottles went to CLAMP mode (Fig. 4.F). Altitude capture was still armed. Three seconds later the autopilot automatically switched to altitude capture mode. The FMA arm window went blank and the pitch window showed ALT/CAP (Fig. 4.G). A tenth of a second later, the Captain adjusted the vertical speed wheel to a value of about 4000 feet a minute. This caused the pitch autopilot mode to switch from altitude capture (ALT/CAP) to vertical speed (Fig. 4.H). Climbing through 4500 feet, the FMA showed: [SPD/255 || *blank* || VOR/TRK || VERT/SPD] and the approaching altitude light was on. As the altitude passed through 5,000 feet at a vertical velocity of about 4,000 feet per minute, the Captain remarked, "Five thousand. Oops, It didn't arm." He pushed the MCP ALT/HOLD button and switched off the autothrottle. The aircraft continued to climb to about 5,500 feet and the "ALTITUDE - ALTITUDE" voice warning sounded repeatedly.

The immediate cause of the aircraft descending before reaching the cleared altitude of 5,000 feet can be attributed to two actions taken by the Captain: 1) his selection of the IAS pitch autopilot mode, and 2) his decision to disconnect the autothrottle and reduce thrust. In IAS pitch mode, the autopilot adjusts the aircraft's pitch angle in order to maintain the target airspeed set in the MCP speed window. Usually this pitch mode is used during climb with the thrust set to climb thrust, or during descent with the thrust at idle. In this case, the thrust was not sufficient to climb and maintain the MCP target speed of 240 knots and the aircraft started to descend.

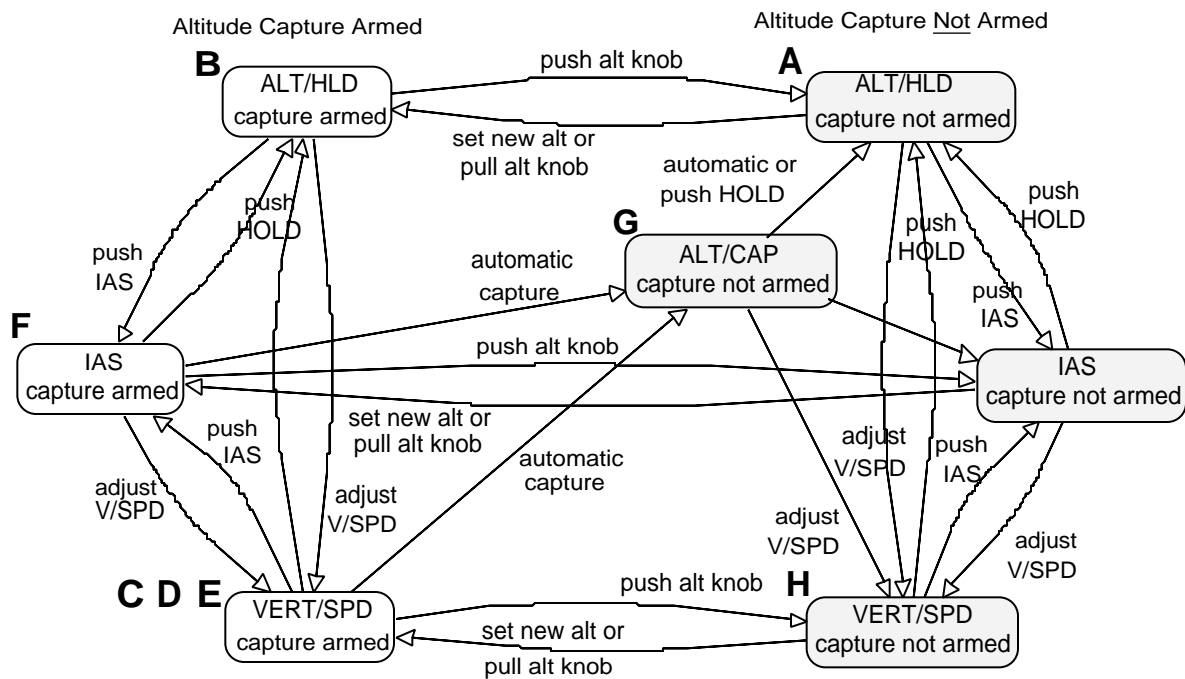
Figure 5. Pitch autopilot modes. The bold letters show the sequence of pitch modes that occurred in Case 2.

Vertical speed is the basic pitch autopilot mode; pushing the MCP VERT/SPD button or adjusting the vertical speed wheel causes the pitch autopilot to switch to the vertical speed pitch mode. Two different mode configurations occur during an autoflight climb to a new target altitude. When a higher target altitude is entered in the MCP altitude window, altitude capture becomes armed. This is indicated by the letters, "ALT", appearing in the arm column of the FMA (fig. 4.B). The pilot next selects a pitch autopilot mode and thrust autothrottle mode for the climb; typically the pitch mode selected is either vertical speed (VERT/SPD) or IAS. During the climb, the autopilot continually checks the difference between the MCP target altitude and current altitude and the vertical velocity to see if the conditions are satisfied to switch to the altitude capture (ALT/CAP) pitch mode. When the autopilot automatically (and silently) switches to ALT/CAP mode, the autopilot smoothly pitches the aircraft to level out at the target altitude. Once the altitude is acquired, the pitch mode switches to altitude hold (ALT/HLD). When the pitch mode switches to ALT/CAP, the letters, "ALT", disappear from the ARM mode annunciator and altitude capture is no longer armed (Fig. 4.G). Figure 5 illustrates how the autopilot pitch and altitude capture arm modes interact.

The autopilot pitch mode can be changed during a climb to a target altitude without disarming the altitude capture. The system is primed for error only after the pitch autopilot automatically switches to the ALT/CAP mode. Adjusting the vertical speed wheel causes the pitch autopilot mode to change from its present mode - in this case, ALT/CAP - to vertical speed (VERT/SPD). Since altitude capture is no longer armed, the capture has been "killed," and if the pilot takes no further action the autoflight system is configured to climb the aircraft through the target altitude set in the altitude window.

This is a classic example of a mode error. Mode errors occur when the same pilot action - in this case, adjusting the vertical speed control wheel - results in different system behavior depending on what mode the machine is in. During the climb while altitude capture is armed, the pilot can change the pitch autopilot modes at will and altitude capture will remain armed and the autopilot will level the aircraft at the set altitude. However, once the autopilot has transitioned to the altitude capture pitch mode (ALT/CAP), adjusting the vertical speed wheel will cause the autopilot to switch to the vertical speed mode and the aircraft will no longer level off at the MCP target altitude. Adjusting the vertical speed wheel always puts the pitch autopilot mode in the vertical speed mode.
